Final Report  
CPAR-SL-98-1  
September 1998

# **Technologies for Improving the Evaluation and Repair of Concrete Bridge Decks: Ultrasonic Pulse Echo and Polymer Injection**

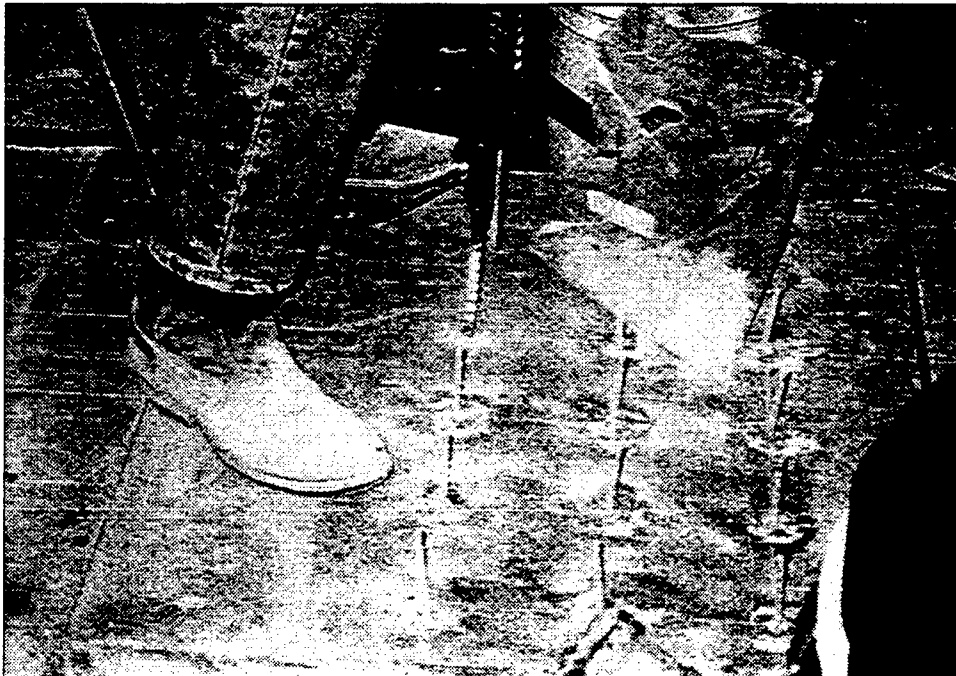
Figure 37. Drilling operation

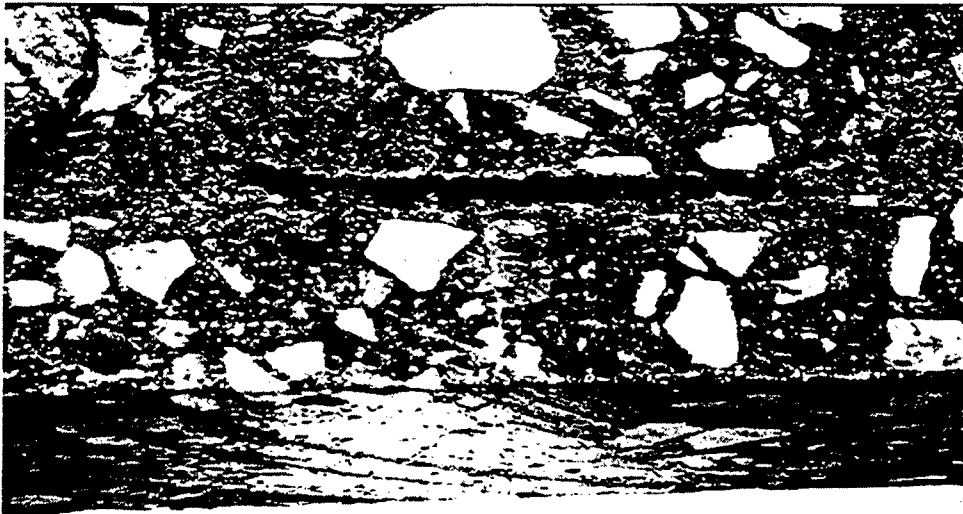
Figure 46. Failed specimen

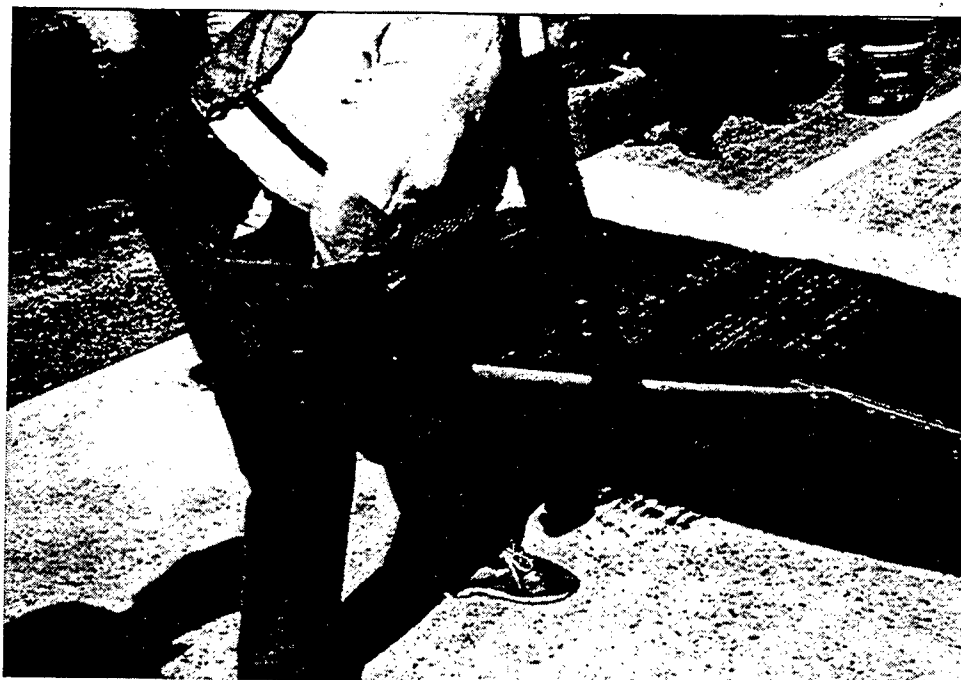
Figure 65. Material placement for Category-I overlay

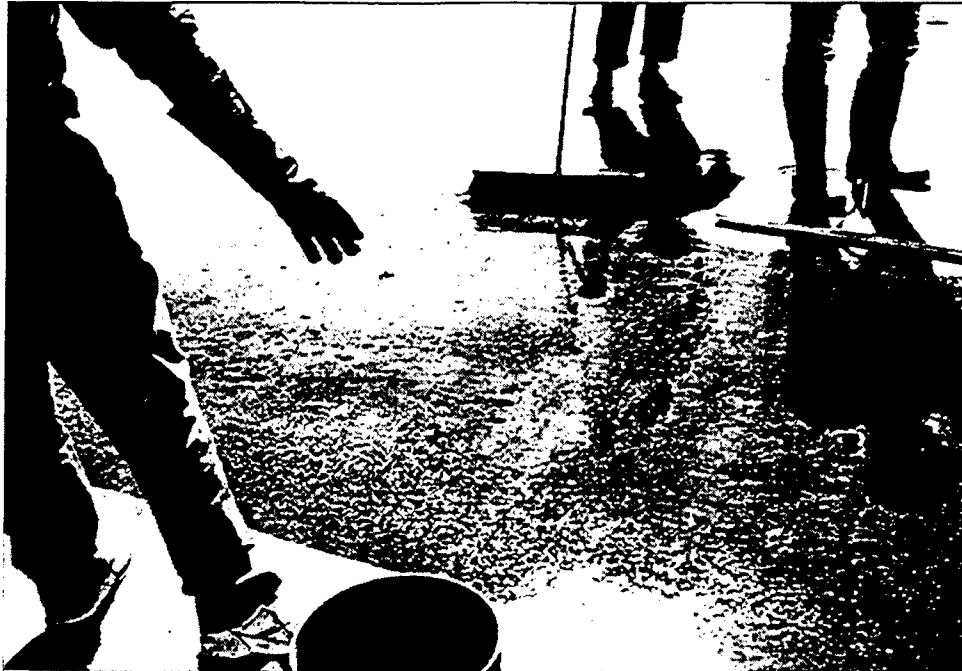
Figure 67. Material placement for Category-II overlay

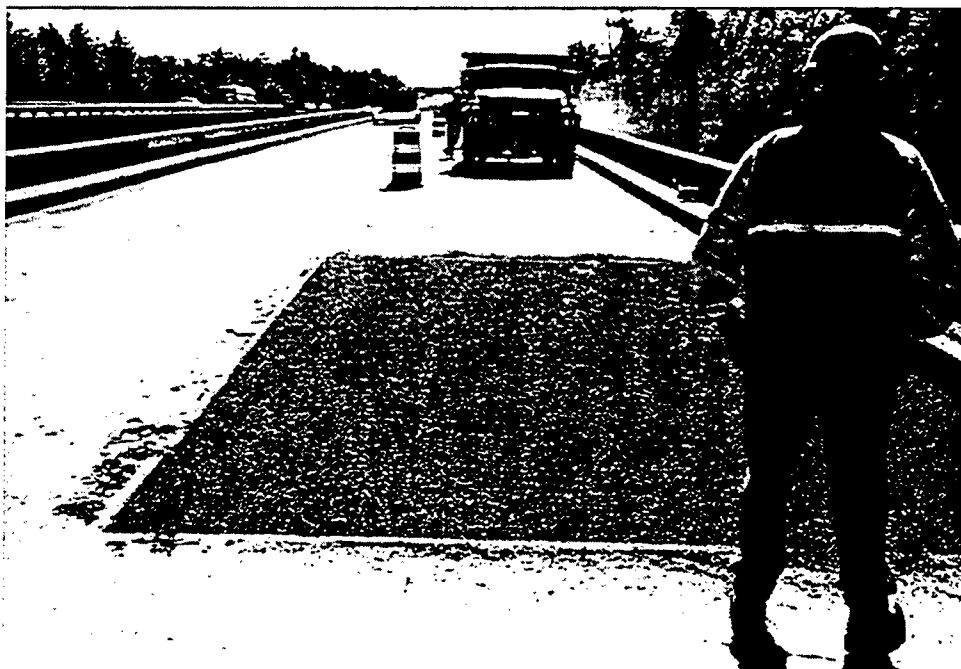
Figure 68. Finished Category-II overlay

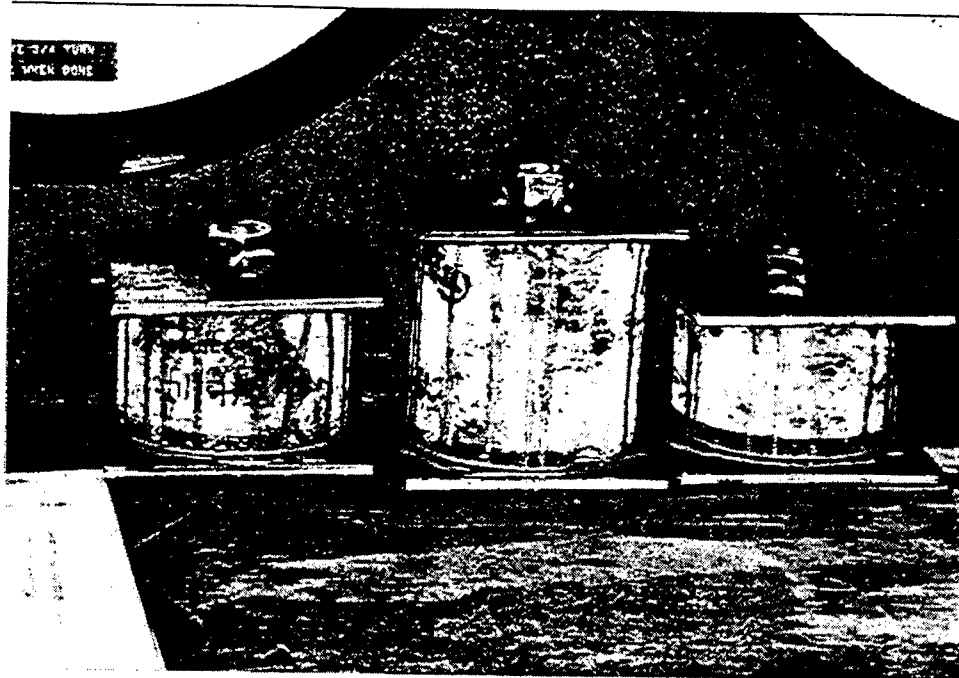
Figure 73. Tensile test specimens

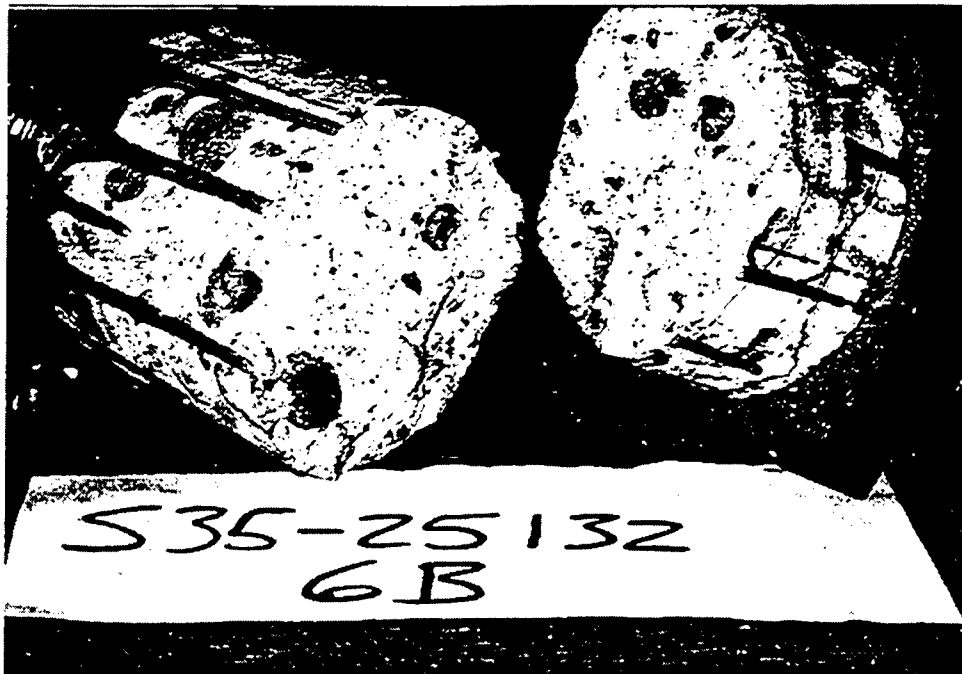
Figure 75. Specimen after tensile testing

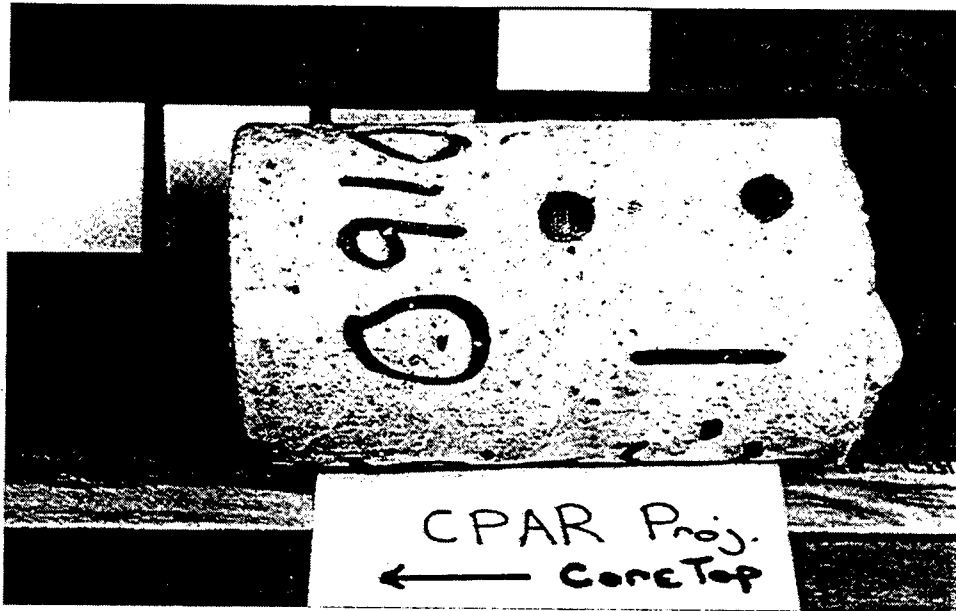
Figure J1. Core Sample No. S05-09101-C-1. Profile view of 4-in.-diam bridge deck core showing overall size, condition, and presence of steel reinforcement (two circular objects imbedded in the concrete)
